# Problem: Piston Pump Failures on a High Cycle Punch Press

## Previous Solution: Hydraulic Storage System Retrieval Car Crash

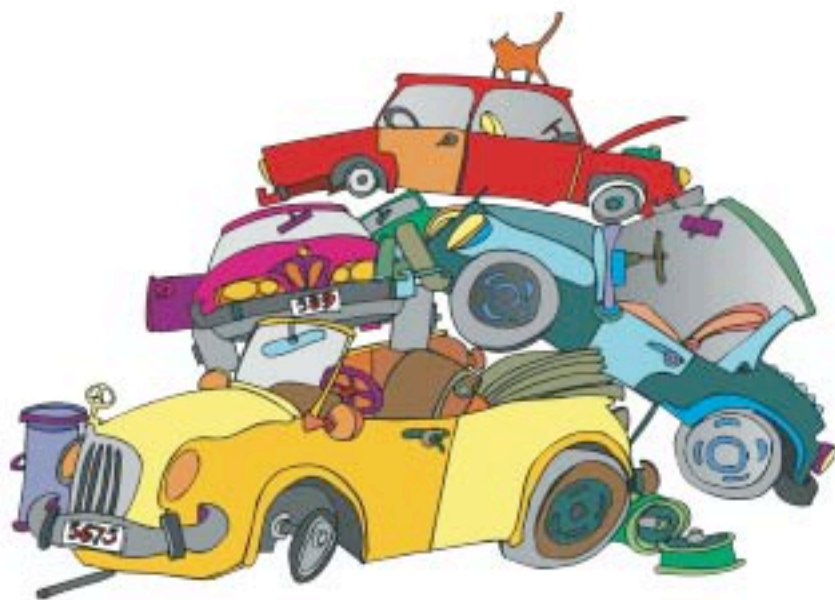
The retrieval car hunting problem was caused by a low spot worn into the rails. Every time the car was told to move, the steel on steel wheels and rail would slip and spin during acceleration of the car. This constant spinning wore a low spot on the rail. When the encoder tried to position the car to allow extraction of a cab, it would stop at a point where the worn spot started, and the car wanted to move slightly and rest in the bottom of the worn groove.

But why did the car jump the end barrier of the rails instead of stopping when commanded? The Sun brake valve should have prevented this. Sun brake valves are designed somewhat differently than the normal industry standard valves. To increase the pressure setting of the Sun valve, you must turn the adjustment knob counterclockwise and to lower the setting, clockwise. This is opposite of most valves, and the technician (yours truly) didn't know this. With a low setting, there wasn't any braking force on the drive motor, creating a run-away condition.

The fix was to move both rails 1 to 2 inches forward so the groove was away from the stopping points. The acceleration ramp was also increased so the wheels started slowly and ramped up without spinning the wheels.
